Structural Characterization Assessment of RC Buildings after Gorkha Earthquake 2015

ABSTRACT: After the Gorkha Earthquake Nepal 2015, several buildings were damaged and collapsed in Kathmandu valley. In this context, the proposed paper presents an overview of the damage that was observed and the general and detail information collected through Rapid Visual Damage Assessment of 64 numbers of buildings around the Kathmandu valley. The main objective of this research work was to make the database of damaged buildings, to find out the general causes of failure of these buildings, to know the lesson learnt from the Gorkha earthquake 2015 and to recommend for design and construction of RC building in future. The existing status of the buildings are obtained by analysis of collected data in which general information and deficiencies of buildings are plotted out by using statistical tools, then correlation between these parameters is performed. The study showed that the selected buildings lie in IX MMI comparing with the seismic hazard map of Kathmandu valley prepared by UNDP.

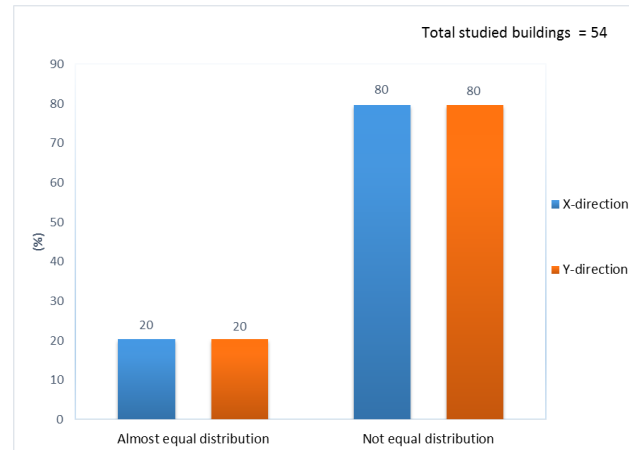
Fig 0.d : Distribution of infill walls

The distribution of infill wall is not regular as shown in Fig 0.d This unequal distribution of infill wall increases unequal distribution of stiffness which cause torsion in the building during earthquake.

The geometry of the building should be symmetrical from both major direction and there must be equal distribution of infill wall in both direction as far as possible. The flexural and shear reinforcement provided in column is not sufficient, hence capacity design with strong column weak beam principle is recommended. The workmanship of the concrete work is not satisfactory, so it is better to use concrete mixer and vibrator instead of manual mixing and compacting. Regarding the reinforcement, it is better to use Tor steel rather than TMT . It is recommended to avoid soft story evidence, short column in the buildings design and soil test is recommended for any construction to avoid settlement and tilting. To prevent brittle failure, ductile detailing should be followed as per the norms. In addition, enforcement of codes should be strict and built the structure only after proper analysis and design.

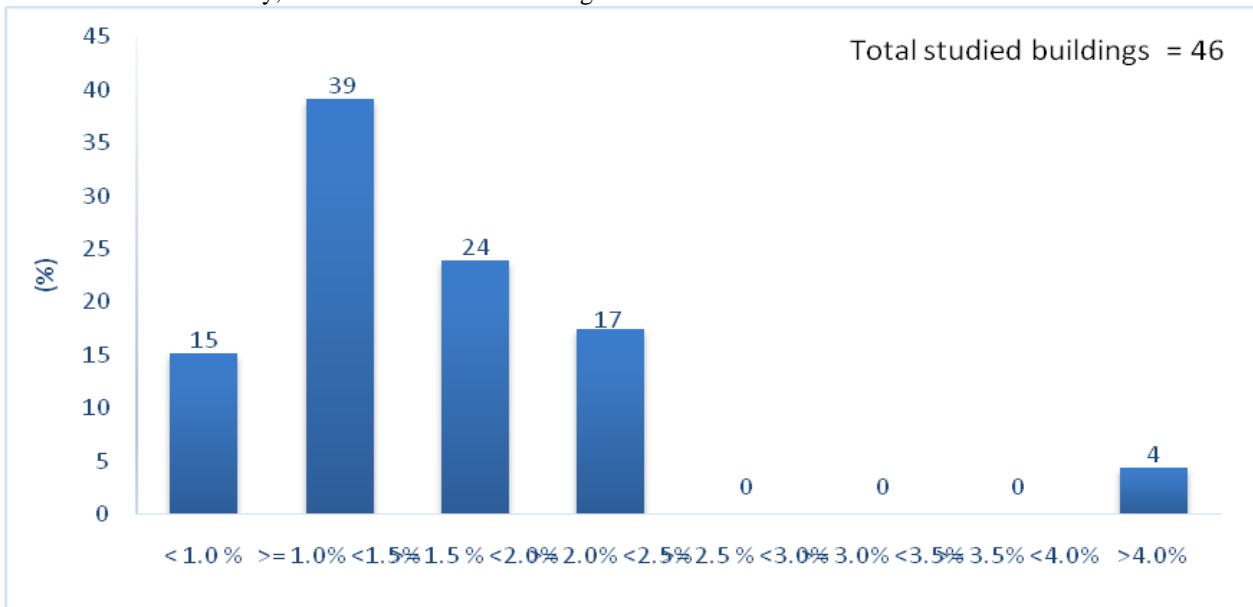
Fig 8.a : Longitudinal reinforcement percentage in columns

Longitudinal reinforcement is one of the important parameter that signify the vertical load and bi-axial bending moment capacity of column. Fig 8.a shows 15% buildings have less than 1% reinforcement. The highest numbers of buildings of 39% have longitudinal reinforcement of equal and greater than 1% and less than 1.5% followed by 24% of building have reinforcement of equal and greater than 1.5% and less than 2%. Similarly, about 17% of the buildings

have longitudinal reinforcement equal and greater than 2% and less than 2.5%. Only 4% of buildings have reinforcement >4%. There are no buildings found which have reinforcement from 2.5-4%. Actual reinforcements in columns are less than required even though in chart it shows higher value because sizes of columns sections are quit smaller than required otherwise it would be lesser than that.

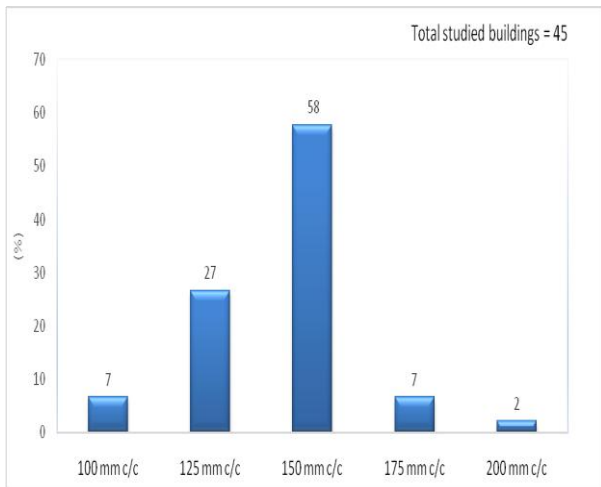
Fig 8.b : Stirrups spacing at support of columns

Transverse reinforcement in column are not visible in most of the cases, however most of the building(58% out of considered 45 buildings) have spacing of 150 mm with diameter of 7 and 8 mm at near the support of column (see Fig 8.b) even though in approximate calculation it needs

100 mm center to center but it is seen that only 7% buildings have this amount of reinforcement. Diameter of transverse reinforcement is mainly used of 7 mm diameter and 8 mm diameter. Fig 8.c shows that out of considered 25 buildings, at the mid height 52% building has 150 mm cen-

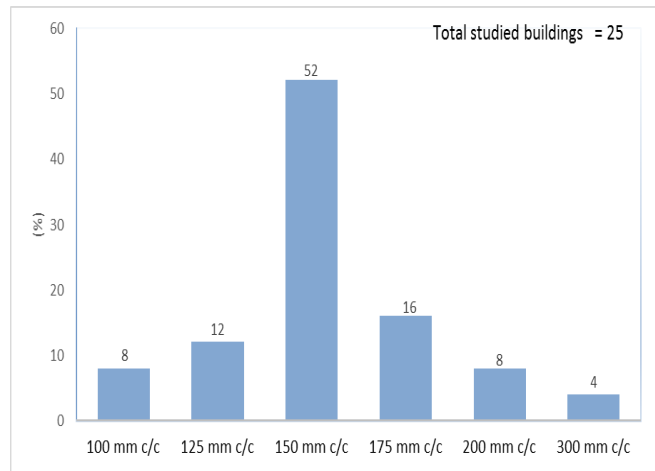
Fig 8.c : Stirrups spacing at mid of columns

ter to center transverse reinforcements. From this two charts, it can be seen that at mid height of column, shear

reinforcements are quite good but near the support of columns, they are not enough.

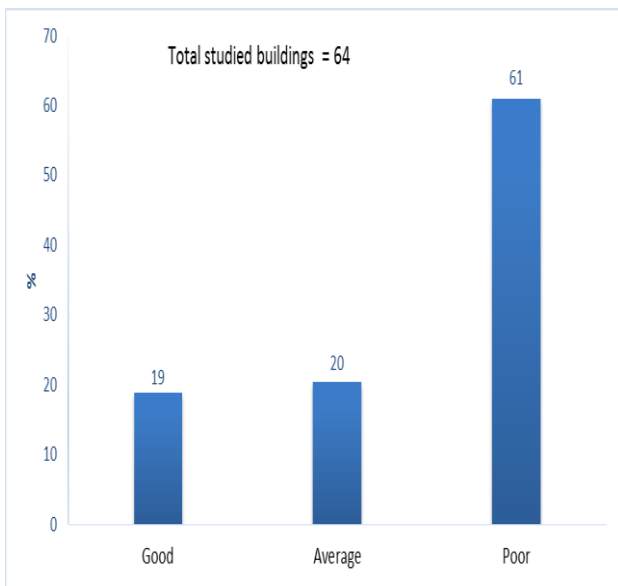
Fig 10.a : Quality of concrete

Quality of material also influence the strength of the structural members and consequently to structural system itself. Fig 10.a shows that out of studied 64 numbers of buildings, 61% of buildings have poor quality of concrete. Similarly, Fig 10.b shows that the quality of concrete in vibration shows 52% buildings have poor quality. This is the

cause for the crushing of concrete in the column support and joint. The results show that TMT steel were used mostly in the buildings which are more vulnerable in compared to Tor steel used buildings (see Fig 10.c). This might be because TMT have less ductility than Tor steel.

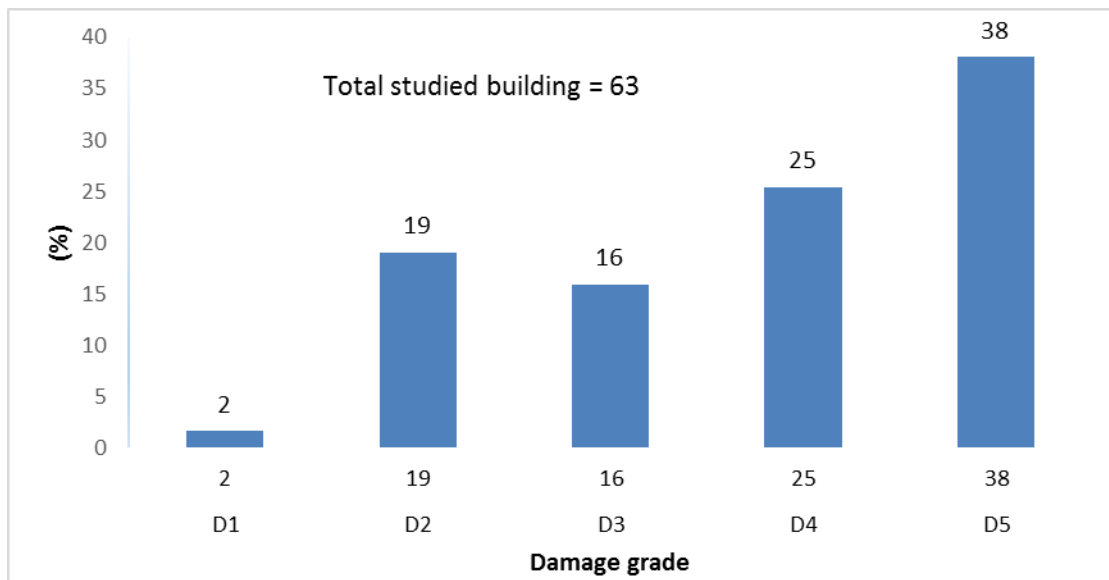
Fig 11.a : Classification of building based on damage grade

Damage of the building can also be classified according to European Micro-seismic Scale (EMS 98). Fig 11.a shows that out of 63 studied buildings the highest percentage of buildings of 38 % lies in damage grade D5 followed by D4, D2, D3 and D1 respectively.

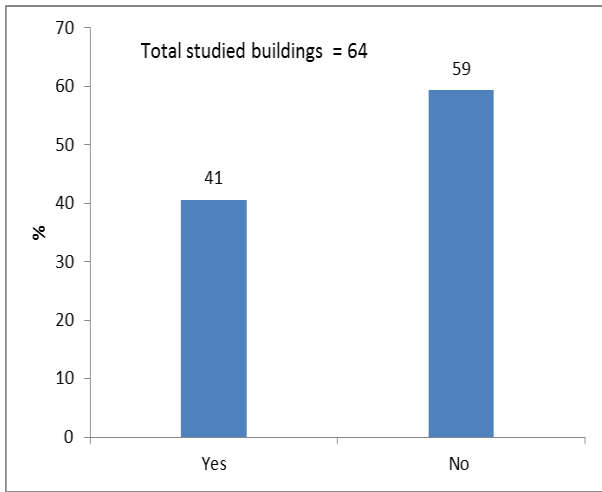
Fig 11.b : Classification of building according to soft story

The analysis of data collected from field survey shows that soft story failure evidence is observed in 41 percent of building. Fully collapse of ground floor, most of the damages of ground floor columns with respect to above stories is considered as a soft story evidence.

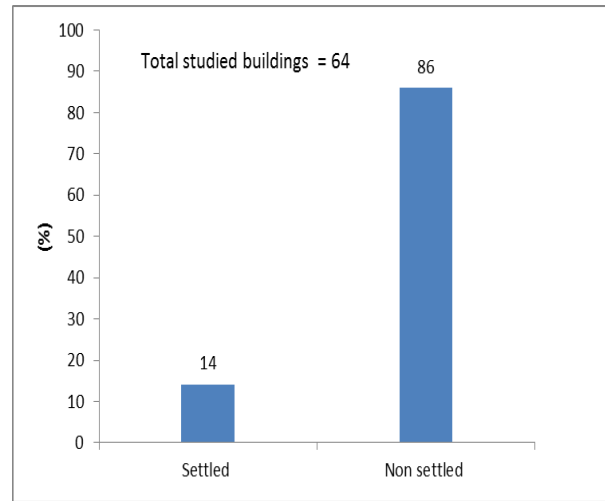
Fig 11.c : Classification of buildings according to settlement

Due to very weak soil deposit area, soil amplification, settlement and liquefaction are most probable in this zone. The graph in Fig 11.b shows out of studied 64 buildings,

14% building are settled. It happens due to foundation in weak soil, not enough size of foundations, heavy load in small foundations, unequal level of foundation footings, different soil strata in different footing, high water table and other causes.

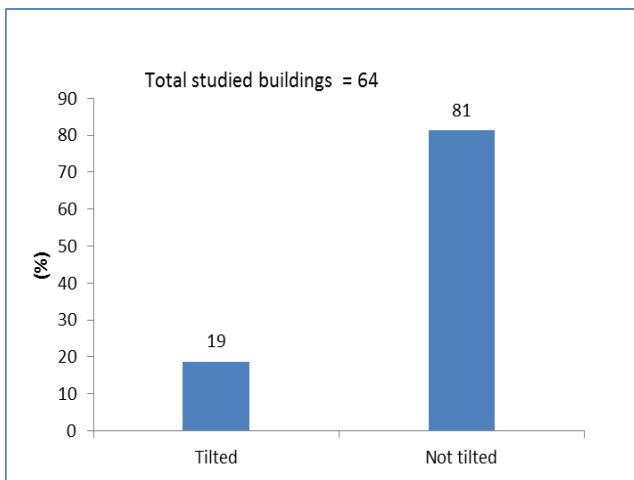
Fig 11.d : Tilting of buildings

It is believed that Kathmandu valley have high soil deposited of up to about 600 m (source: slide of B. N. Upreti). Tilting of building is observed in some of the building. It is observed that 19% of buildings from the 64 studied buildings seem tilted (see Fig 11.d). It is due to weak soil, very slender building, unequal mass in plan is and in elevation.

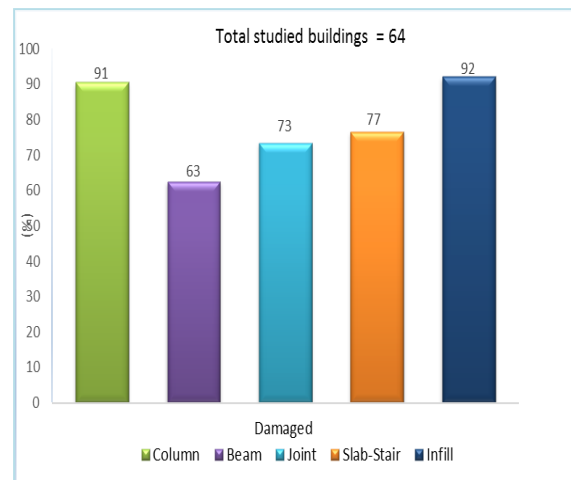
Fig 11.e : Damage of structural elements

Damage of the structural elements such as column, beam, joint, slab-stair and infill are plotted in Fig 11.e. The results show that the most probable damage are observed in column and infill followed by slab-stair and joint. The least damage was observed in beam, this might be because of strong beam weak column mechanism.
