Initial Failure Analysis of Lubricating Oil Pump shaft

Pradeep Pawar¹, Pankaj Gambhire², N. S. Hanamapure³

Abstract: - This paper deals with initial detailed failure investigation against field compliant of a lubricating oil pump rotor shaft used in a Diesel generator engine. The investigation mainly included detail visual analysis for shaft failure by analyzing its chemical composition, microscopy, fractography, Millipore & hardness analysis. Analysis revealed that the basic casting manufacturing processes may responsible for the failure. The paper gives how the photographic views help to generate correct investigation path. The shaft is may failed basic requirement of casting internal cleanliness before assembly of the pump. The twist in the shaft is the main cause for the pump failure. Millipore value of the pump is at higher side and it also may be the cause for the shaft failure. All visual observations are put forwarded with the detailed photographic views to analyze the pump failure & decide the further investigation. This paper says that how the visually diagnoses gives direction for the pump failure investigation.

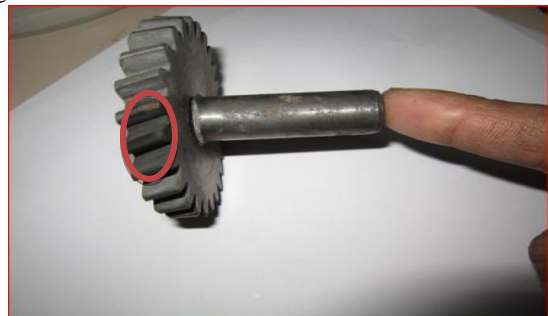
- 1) Shaft, lubricating pump drive found twist as shown if fig. 1

Fig. 1 Twisted shaft and gear assembly

Shaft twist is observed on the fracture surface on the shaft OD. There is bending on the gear face observed.

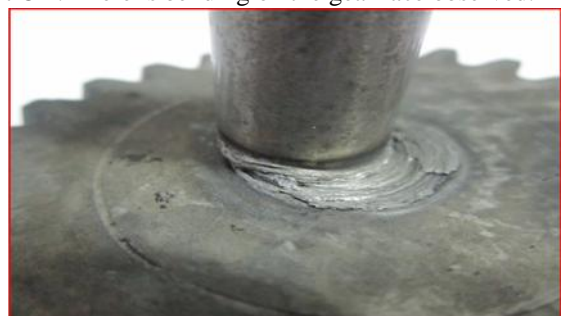
Fig. 2 Dislocated shaft

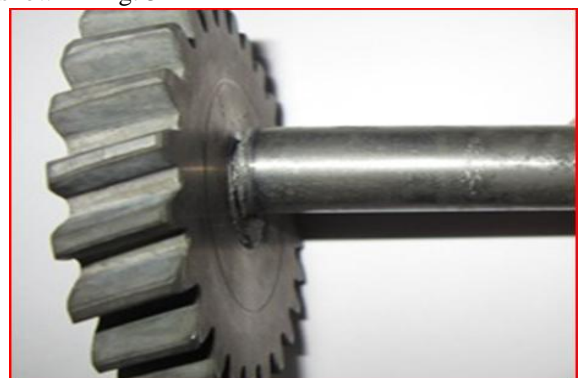
The gear is bended and shaft is shifted from his place as shown in fig. 3

Fig. 3 Gear bend and shaft dislocate

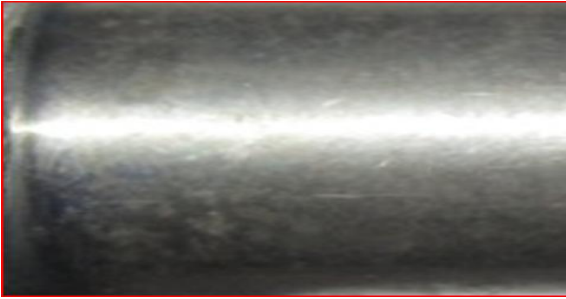
2) Stereomicroscopic photographs of the step near fracture on which no any other marks

Fig. 4 Stereomicroscopic photographs of the step near fracture

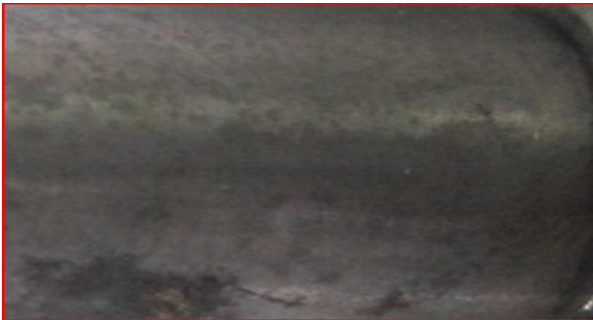
Fig. 5 Stereomicroscopic photographs of the step near fracture with 12 X Magnification

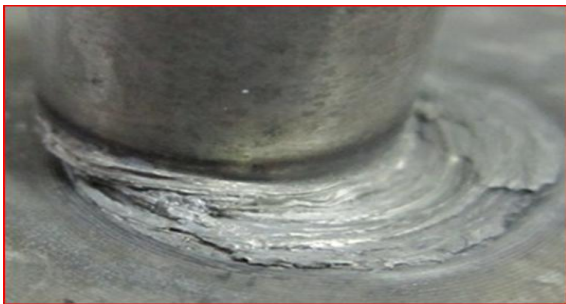
1. No ratchet marks around the periphery.
2. Beach marks are not visible.
3. The metal smearing is apparent on the fracture surface.
4. The entire fracture surface has a no smooth texture and no well-defined final fracture area.

All the observations clearly indicate that the failure mode is torsional shear. Also discoloration is observed on the fracture surface at some locations.

Fig. 6 Twist of shaft.

Discoloration is observed at some locations on the fracture surface as shown in fig. 6

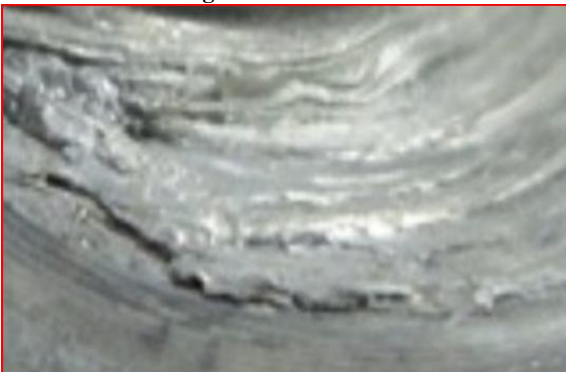
Fig.7 Stereomicroscopic photographs of fracture surface with 6X Magnification

Bushing material found embedded near the fracture surface of shaft OD as shown in fig. 7

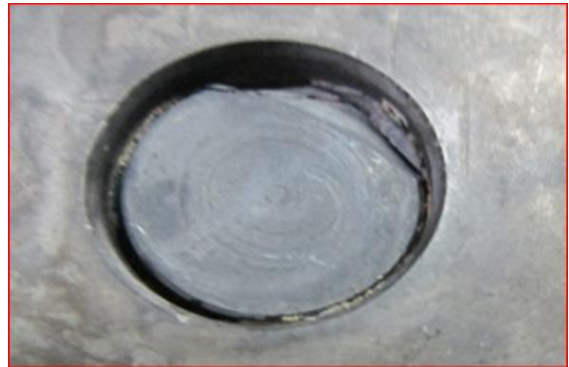
Other end of the shaft is in the gear & it shown in fig. 8. The shaft material is removed & cracked due to high load generated at this end.

Fig. 8 one end of shaft in gear

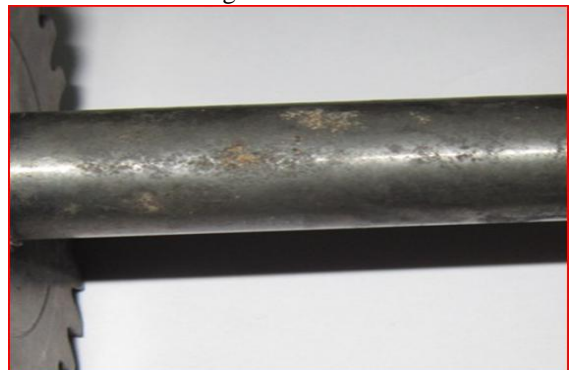
5) Shaft middle portion contains material removal & deposition of other material.

In the below figs. 9-10 the material on the shaft is removed on one side of the shaft & other end material is deposited as shown in fig. 11

Fig. 9 Middle portion of the shaft.

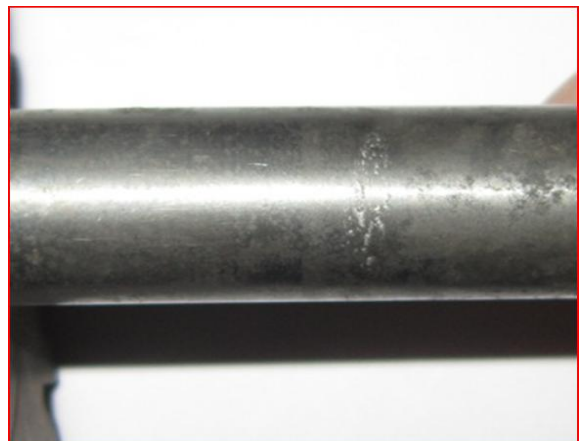
6) Material deposition on the shaft

Fig. 10 Material deposited on the shaft.

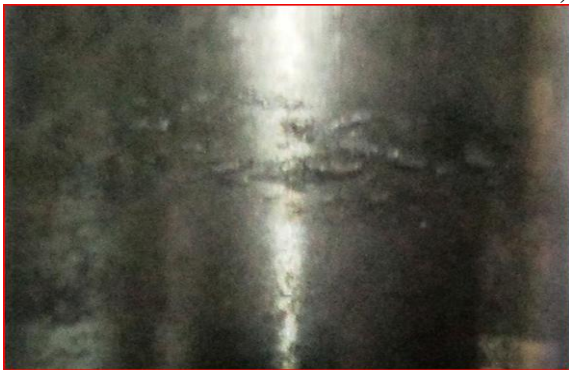
Fig. 11 Shaft view with 6X Magnification.

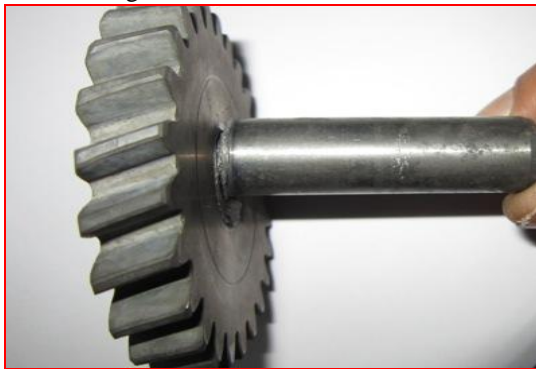
7) The shaft is found bend near the fracture location.

Due to this bend the shaft is contacted with the chamfer at the gear. Contact marks are observed at the chamfer of the gear at one sector corresponding to the bend observed on the shaft. The detailed photos are attached in the fig. 12-15.

Fig. No. 12 Shaft bend near gear face.

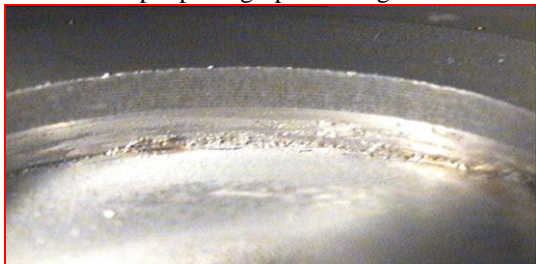
Fig. 13 Chamfer mark on gear with 6X magnification

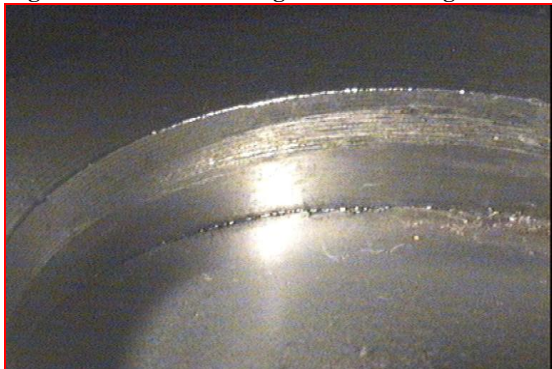
Fig. 14 Both ok and contact mark with 6X magnification

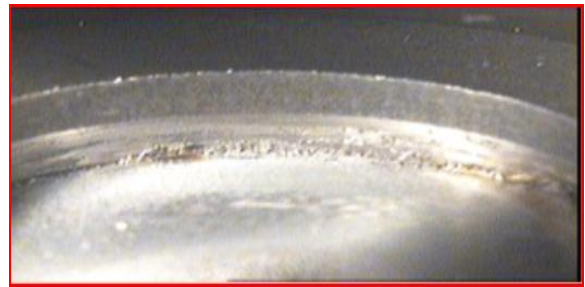
Fig. 15 Gear Contact mark

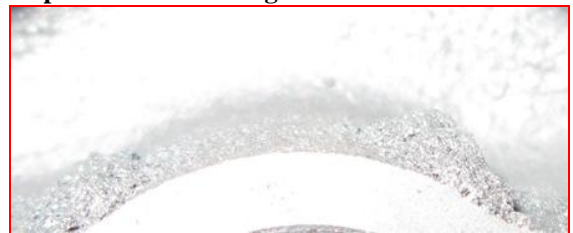
8) Sand found below rotor in casting pocket of suction.

Fig. 16 Sand at casting pocket

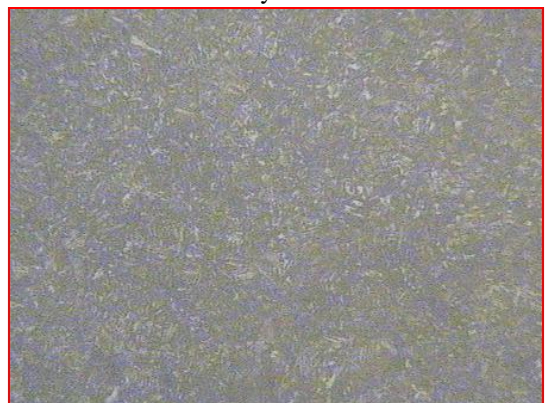
Cut section 1.

Fig. 23 Shaft microstructure reports with magnification 100X

Shaft microstructure checked found ok as per fig. no.
