Engineering Properties of Building Materials in Historic Buildings in Bagamoyo (Tanzania)

Dr. Charles Lucian, School of Real Estate Studies (SRES), Ardhi University (ARU),
P.O. Box 3516, Dar es Salaam, TANZANIA

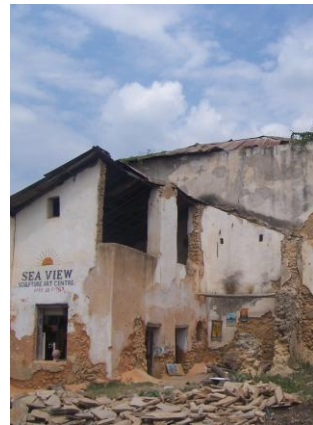
Fig 1: Incurably deteriorated historic building falling apart inside and out in Bagamoyo, Tanzania

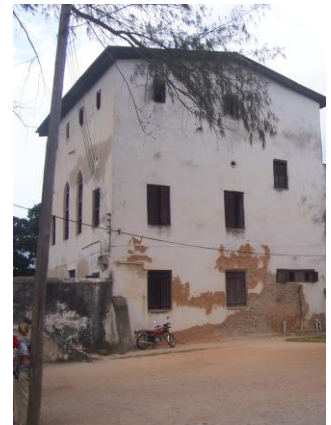
Fig 2: Lime plaster falling off the external wall of the Old Fort in Bagamoyo, Tanzania

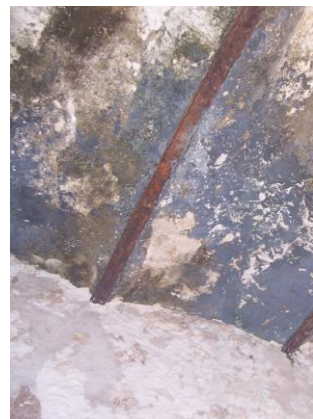
Fig 3: Condensation, dampness and mould growth on the slab of the Old Boma

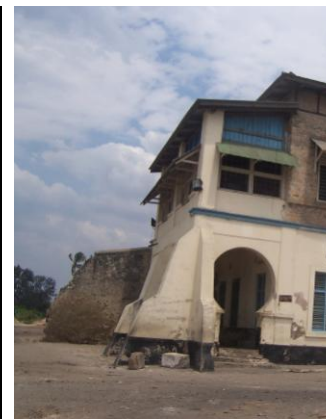
The identification of damages and technical condition of historic buildings is very important prior to identifying and undertaking appropriate preservation measures. The buildings were looked for evidence of condensation and black mould staining, peeling of rendering and plaster, disintegrating mortar. Most of the Bagamoyo buildings have born too much stamp of wear and tear because of dearth of serious maintenance for centuries. Some buildings are completely falling beyond economic repair (Figures 1). The dilapidation survey or revealed that the lime washed plastered walls have eroded and lost their outer skins in some areas due to the action of climate mainly wind, temperature and rain (Figure 2). In certain cases the friable mortar has completely disintegrated into dust leaving the lime-stones and coral stones completely exposed. Close examination revealed that the cause of the disintegration in the masonry elements is rooted in the deteriorated mortar leaving the limestone and coral stone firmly intact. It is from this fact that most physical and chemical tests were mostly directed at the mortars and little allusion was paid to the walling materials. Further examination revealed some roof leakages in some historic buildings to the extent that damp patches and condensations are penetrating the ceiling (Figure 3). In the efforts to restore the some buildings, incompatible materials (e.g. cement sand blocks instead of limestone) were used (Figure 4). The use of different materials is likely to cause differential expansion.

Fig 4: Use of cement sand blocks not similar to the original limestone on German Customs House in Bagamoyo, Tanzania

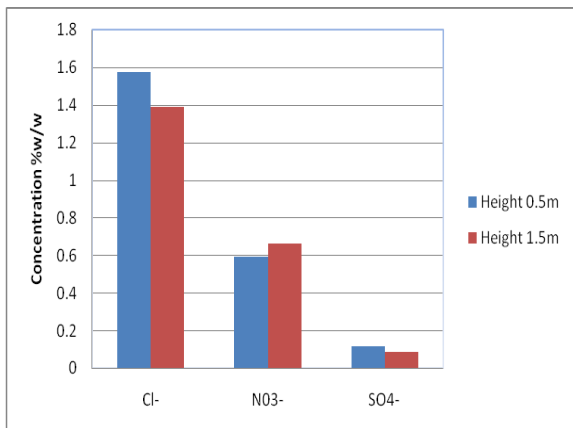
Fig 7: Types of Soluble Salts with Heights

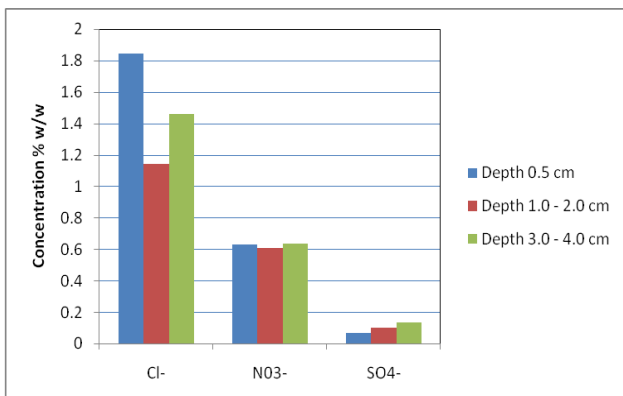
Fig 8: Types of Soluble Salts with Widths
