Design Analysis of Lubricating Pump Rotor Shaft for Fatigue

Abstract:-This paper deals with fatigue analysis of lubricating pump rotor shaft of diesel engine which used at generator set. This analysis is done after failure of pump shaft under warranty period at customer end. After first visual analysis it is concluded that this failures may be pre mature fatigue failure due to under design of shaft. In this paper detail fatigue analysis of shaft is done and results of analysis are verified with experimental and FEM analysis.

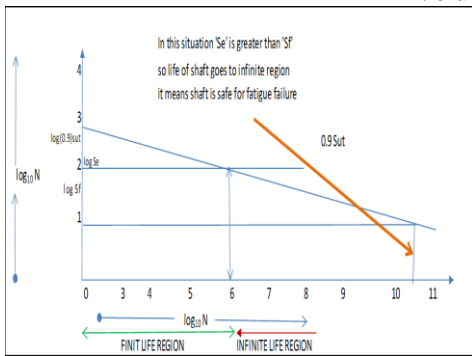
Fig 4 S-N Diagram for shaft.

From the analysis, infinite life of lubricating pump rotor shaft is obtained.

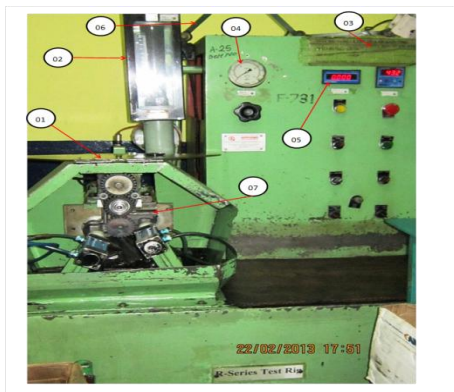
The test rig is manufactured company. It is used to test the pumps by simulating the actual working condition. It is simply made up of the motor and pulley connection to drive the pump. The test rig provides measurement of output flow, delivery pressure, pump rpm and working temperature.

Fig 5 Test Rig Assemblies

1. Motor.
2. Flow meter.
3. VFD (Variable frequency drive).
4. Pressure indicator.
5. RPM indicator.
6. Flow control valve.
7. Pump Mounting fixture.

- Pump back Pressure:- 4.5 kg/cm²
- Oil used:- SAE 40
- Temperature of oil:- 105 ± 50C.
- Minimum speed:- 3250 rpm.
- Maximum speed:- 5000 rpm

Pump is tested by varying speed from 3250 to 5000 rpm for a definite cycle time at 500 hrs. Further radiography testing for crack detection was carried out at NABL (National Accreditation Board for Testing & Calibration Laboratories, India) Lab along with chemical composition and microstructure check.

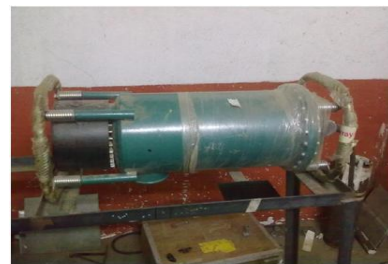
Radiography testing for crack detection

Fig 6 Radiography test machine

- Maximum Von Mises stresses obtained by theoretical analysis is 33.395 N/mm²
- Maximum Von Mises stresses obtained by FEM analysis (Hyper mesh) is 28.8 N/mm².
- The fatigue tests conducted, for the expected fatigue life, has resulted in no crack detection which is confirmed by radiography testing.
- Infinite fatigue life is observed by all the results.

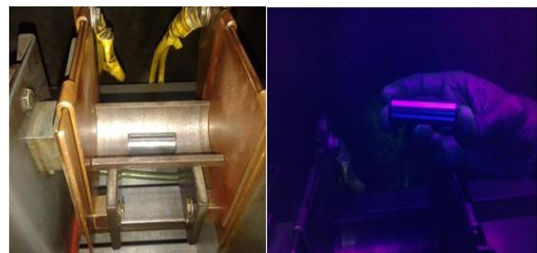
Surface crack detection test

Fig 7 Surface crack test

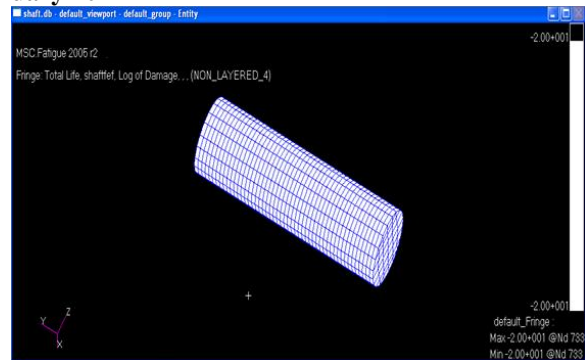
Fatigue life of the pump rotor shaft is obtained by using MSC- fatigue software. The result indicates that for 2000000 cycles there is no initiation of crack.

Fig 12 fatigue life of shaft

- Maximum stress observed is 28.8 MPa.
- Fatigue life obtained is more than 2000000 cycles (infinite life).
