Effect of Vehicular Movement on Petroleum Pipelines at Road Crossing and Cathodic Protection

Jaydeb Manna, Buddhadeb Duari

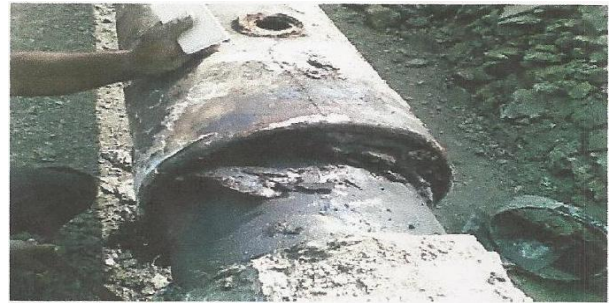
ON PSP	OFF PSP
Pipe to soil Potential of carrier pipe	-1.430V	-1.180V
Casing to soil potential	-1.020V	-0.940V

1. Carrier pipe is well protected cathodically.
2. Casing Potential is high and it is more than - 0.80V and value of casing potential is changing with interrupter. Shorting is suspected.

Fig. 4 Condition of partial shorted casing after excavation Remedial Measure to remove the shorting:

1. Dehydration with compressed air.
2. Change of end seal to avoid further ingress of ground water. But there was no improvement in reading. When there is no improvement in reading after dehydration and replacement of end seal, excavation was stated for the removal of casing. After excavation we have observed that slurry is available in the form of solid inside the casing. Finally casing was removed.

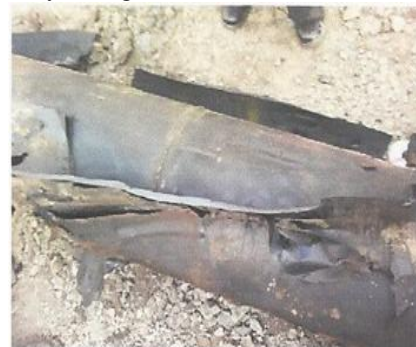
Fig 5.Casing Removal under progress

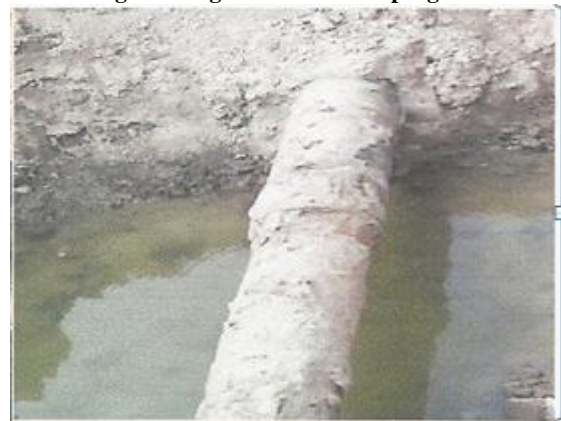
Fig. 6 Condition of casing of old pipeline
