Impact of Slum Rehabilitation Project in Bangalore City: A Case Study of Pantharpalya

III. CASE STUDY OF PANTHARPALYA SLUM

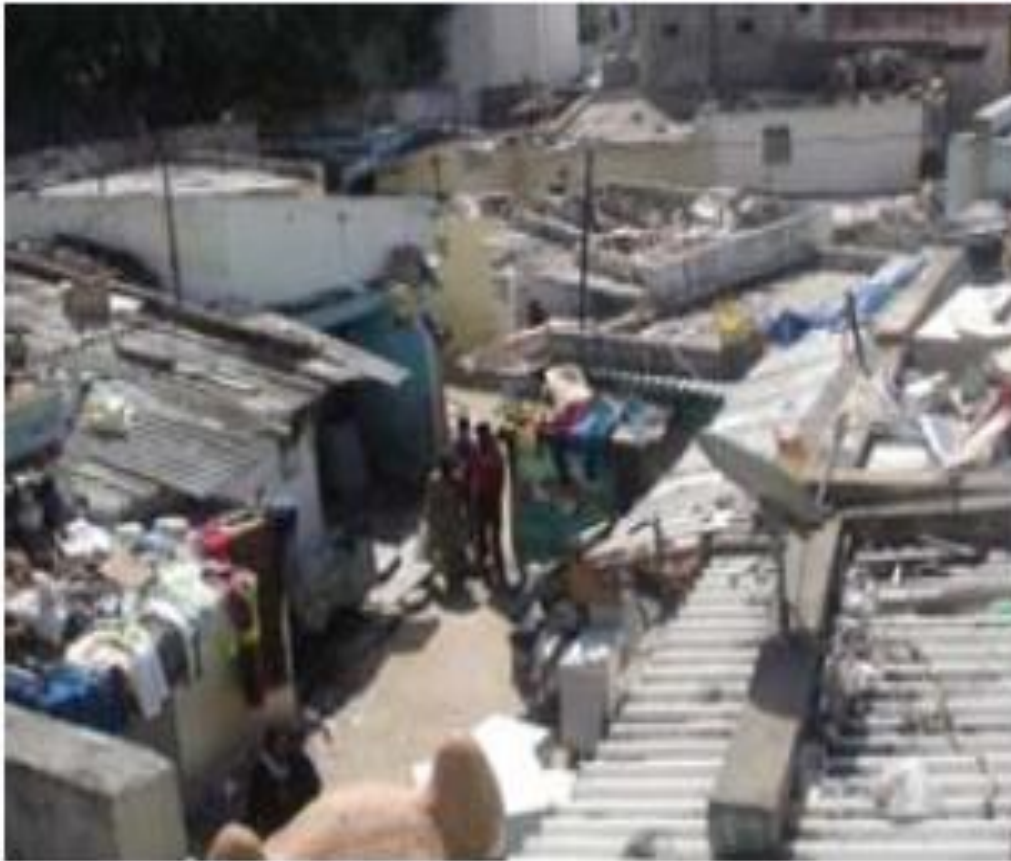
Fig.2 Housing Condition of Pantharpalya Slum

The condition of housing was most vulnerable and the majority of the people lived in kutchha and semi-pucca houses (see fig.2). The situation in terms of socio-economic condition and physical infrastructure namely water supply and sanitation were in vulnerable conditions. People were erected houses according to their wishes and there was no security of land tenure.

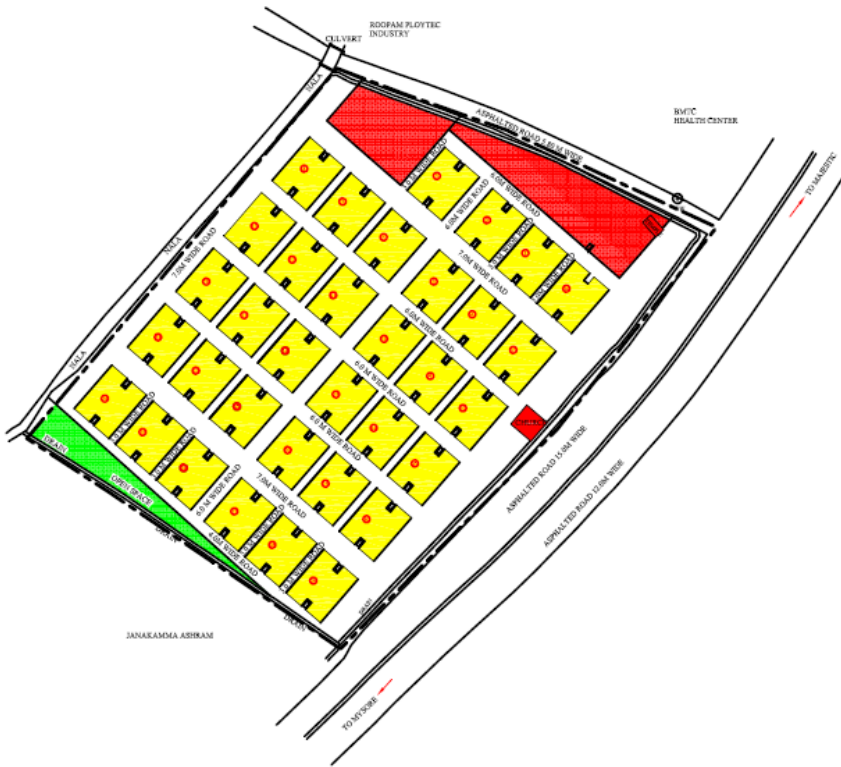
Fig. 3: Neighbourhood Plan of Pantharpalya Slum

PLOT AREA :21150.30 SQM (5.22 ACRES)

LAND USES	AREA	PERCENTAGE
RESIDENTIAL	9208.22 SQM	43.5%
OPEN SPACES	634.50 SQM	3%
CIVIC AMENITIES	1903.52 SQM	9%
ROADS	9404.06 SQM	44.5%

FAR:9208.22 X4 / 21150.30 = 1.74

HOUSING DETAILS		
NUMBER OF BLOCKS	UNIT PER BLOCK	TOTAL DWELLING UNITS
34	32	1088
GROUND FLOOR UNITS	08	272
FIRST FLOOR UNITS	08	272
SECOND FLOOR UNITS	08	272
THIRD FLOOR UNITS	08	272
PLINTH AREA PER UNIT		29.13 SMT
CARPET AREA PER UNIT		25.03 SMT

Dwelling unit density: 516/hectare

REVISED LAYOUT PLAN :
P PANTHARPALYA

Pantharpalya slum was selected for in-situ rehabilitation with a funding from Jawaharlal Nehru National Urban Renewal Mission project under centrally sponsored scheme. In the beginning, it was planned for construction of 896 dwelling units in 24 blocks of 32 dwelling units each; later, the project was re-designed for construction of 1088 dwelling units to cover 34 blocks. Private consultants were engaged to prepare Detailed Project Report (DPR) which includes topographical sheets, layout plans, dwelling unit plans. Estimates were prepared as per Public Works Department's schedule of rates and submitted to State level sanctioning committee (SLSC) through Karnataka Urban Infrastructure Development and Finance Corporation (KUIDFC) in 2006, but the project was revised and approved in 2011 with an estimated cost of Rs.261.17 crore (cost of the dwelling unit was revised from Rs 1.25 lakhs to Rs.1.80 lakhs). The layout plan is shown in fig.3. The residential land use was increased from 34.5% to 43.5%. Open spaces was reduced from 8% to 3%, civic amenities was reduced from 19% to 9%. The dwelling unit density was increased from 410 dwelling units/ hectare to 516 dwelling units/ hectare.

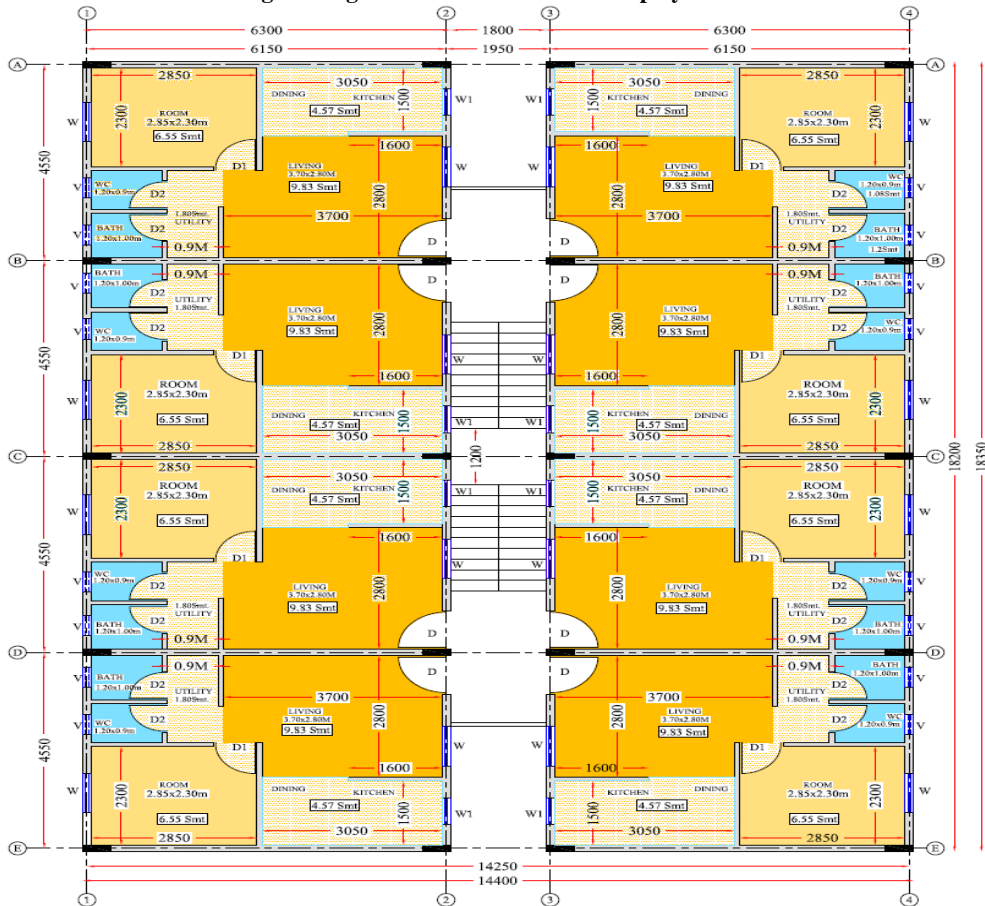
Fig.4: Typical Block Plan of Building

of openings has been to ensure adequate lighting and ventilation, which are some of the factors encouraging a high degree of human activity outdoors, including cooking, washing and sleeping. The typical block plan is shown in fig.4, which reflects the details of designing efficient building envelopes.

The carpet area for each dwelling unit and habitable rooms been on par with the building byelaws and National building code and the details are given in the table 1.

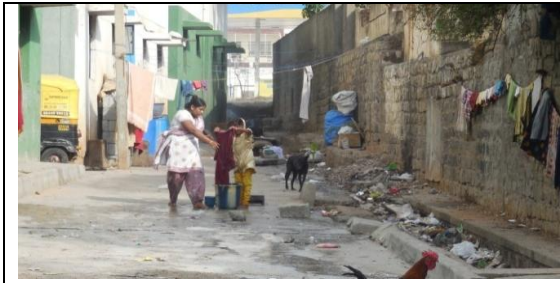
Fig.6 Solid waste is being dumped

into living areas, which led to poor sanitation. Garbage cleared by BBMP twice in a week. Wastes are being dumped in open drains, set-back area and storm water drains as well. There is no provision of community dustbins in the locality. The slopes are inadequate to drain off storm water. Waste water stagnation and garbage disposal in open drains has been common phenomena.

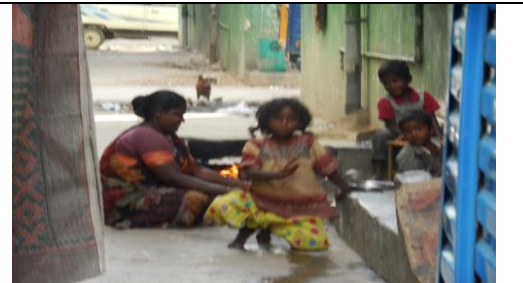
Fig.7 Space used for cooking

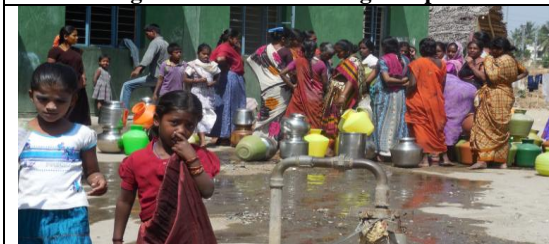
Fig.8 Water scarcity in the locality

There are two tube wells, 68 sumps in 34 blocks of 6000 litre capacity each, 02, 7.5 HP pumps. Also, water is drawn from public taps as well; there is no accountability for the quantity of water consumed by the each of the dwelling units. Residents also have drawn one municipal line to tap water, where water is supplied once in two days for a period

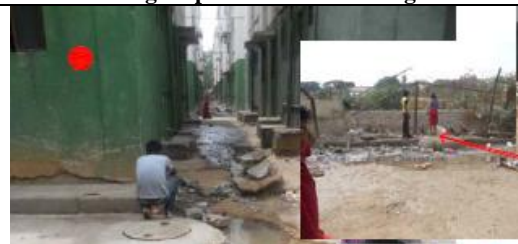
Fig.9 Sanitation problem

All households have access to individual bath and toilet facilities. Poor maintenance, broken pipes and chambers cause frequent blockage and back flow in soil pipes. Sunken slabs were not built in toilet spaces and waste water floods

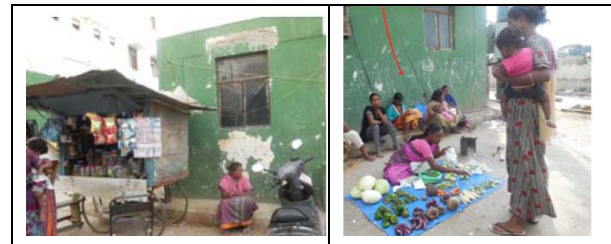
Fig.10 Informal Economic Activities within the premises

Detailed Project Report has been prepared to impart training for 500 slum dwellers from Govt Tool Room and Training Centre and 500 slum dwellers at KEONICS. However, none of the training programmes were initiated. Many of the residents started informal activities within premises in ground floor. About 31% people have access to banks. Thirty Four per cent of the allottees have also earnings from rents and lease of dwelling units. The occupation pattern of slum-dwellers are indicated in table.3.
