Structural Characterization Assessment of RC Buildings after Gorkha Earthquake 2015

ABSTRACT: After the Gorkha Earthquake Nepal 2015, several buildings were damaged and collapsed in Kathmandu valley. In this context, the proposed paper presents an overview of the damage that was observed and the general and detail information collected through Rapid Visual Damage Assessment of 64 numbers of buildings around the Kathmandu valley. The main objective of this research work was to make the database of damaged buildings, to find out the general causes of failure of these buildings, to know the lesson learnt from the Gorkha earthquake 2015 and to recommend for design and construction of RC building in future. The existing status of the buildings are obtained by analysis of collected data in which general information and deficiencies of buildings are plotted out by using statistical tools, then correlation between these parameters is performed. The study showed that the selected buildings lie in IX MMI comparing with the seismic hazard map of Kathmandu valley prepared by UNDP.

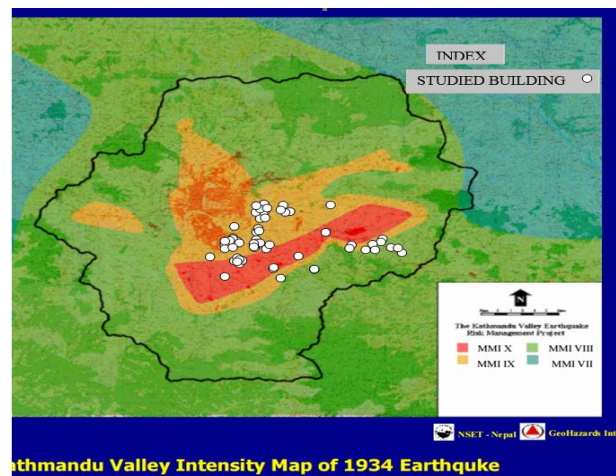
Fig A.b : Kathamandu valley intensity map with damaged building location

For this, the available earthquake intensity distribution map of Kathmandu valley developed by UNDP/UNCHS(Habitat)1994, "Seismic Hazard Mapping and Risk Assessment for Nepal" based on the intensity distribution of 1934 earthquake of Nepal. Comparing the location of damaged building of Fig A.a in hazard map of Fig A.b, one can depicts the intensity of IX MMI (Modified Mercalli Intensity) [4].

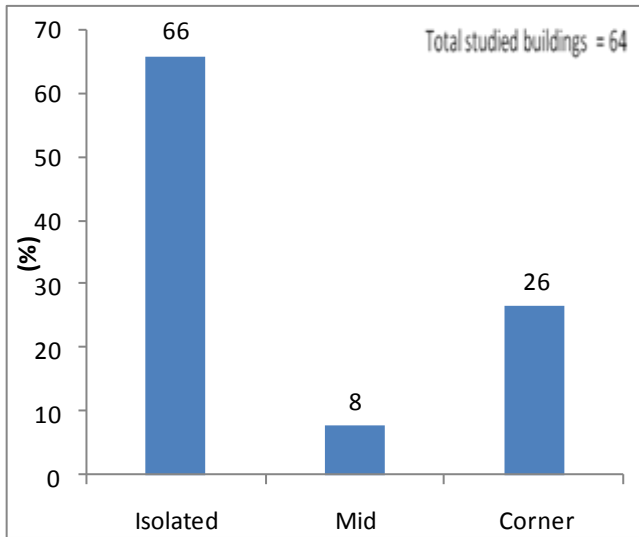
Fig A.a : Position of buildings

Fig A.a shows the categorization of building according to position among the buildings. The results shows that position of building plays vital role relating to vulnerability as 8% buildings which are located in mid are damaged by earthquake out of 64 studied buildings. Isolated buildings were damaged more which reached 66% whereas 26% buildings which are in corner were found damaged. Mid buildings were damaged lesser due to the support in both direction.

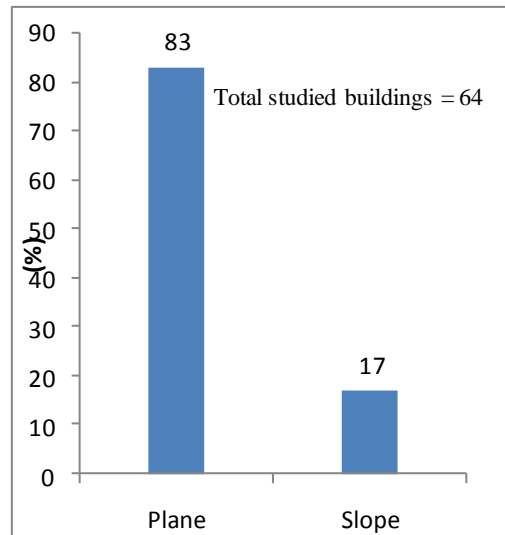
Fig A.b : Classification of buildings according to surrounding terrain

In the geographic terrain building lies in not only in plane but also in sloppy area. So, from the result of graph chart in Fig A.b, it is found that out of studied total 64 numbers buildings, 83% were constructed in plane area whereas 17% in sloppy ground area. Most of the buildings which were constructed in slope area were severely damaged due to unequal settlement of foundations.

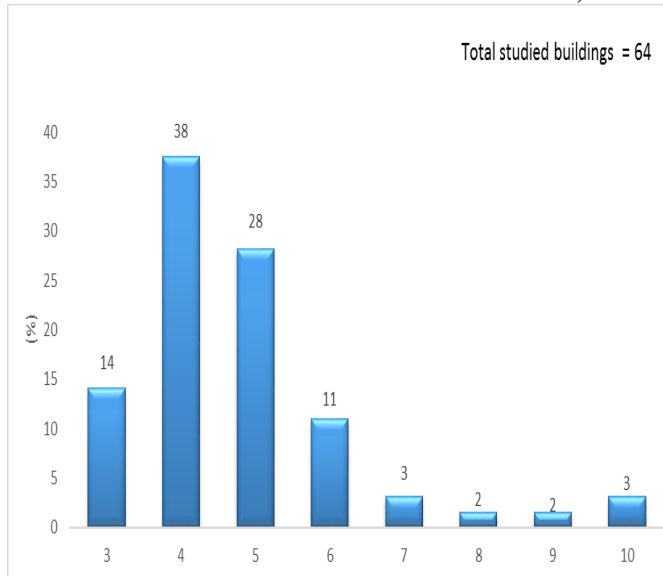
Fig A.c : Damage percentage of buildings in different number of stories

Some information was collected by just looking the building from outside and the results are plotted from available data. Fig A.c shows the scatterness of the building in Kathmandu valley according to number of stories. The result indicates that most of the buildings surveyed are four (including three and half) and five stories (including four and half) which occurred damage in earthquake. Two and half and three storied buildings are considered as three sto-

ried in chart and they are 14% of buildings among the considered 64 buildings. There are 11% of buildings of six stories which were damaged by earthquake. There are less numbers of higher storied buildings.

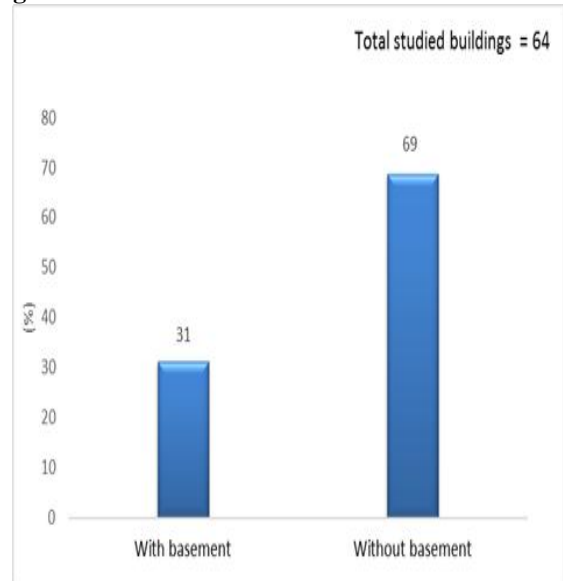
Fig A.d : Status of basement (building with and without basement)

In Kathmandu valley out of total studied 64 buildings, 31% of buildings are with basement and 69% of buildings are without basement. Basements are being used as vehicle parking and storage purpose.

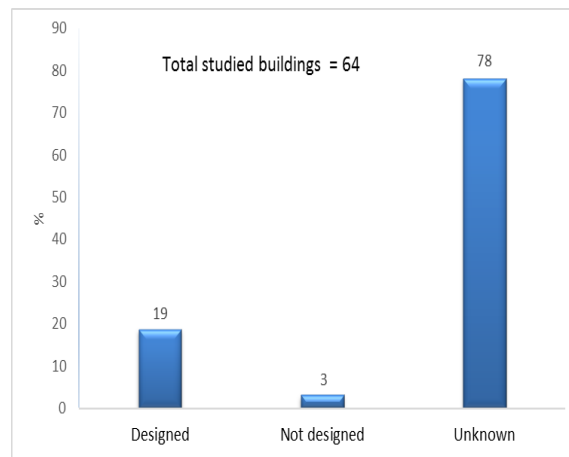
Fig A.f : Structurally designed or not desined building

It is difficult to point out that the building was structural-ly designed from external outlook. Out of studied 64 build-

ings, 78% (50 numbers) of buildings are not known whether they were designed or not. They were almost not designed structurally. It is found that only 19% buildings are clearly known that they were structurally designed (see Fig A.f). And 3 % were known that they were not structurally designed as per information of building owners.

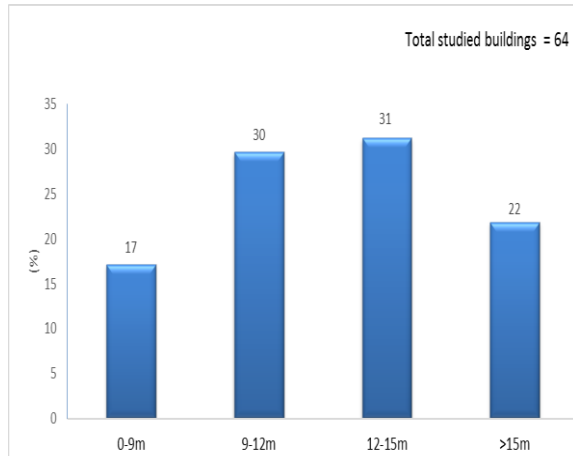
Fig 0.a : Predominant height of building

In the surveyed building of Kathmandu valley most of the damaged building height lies in between 9 -15 m tall (two and half to five stories) (see Figure 3.2a). This is because of these height buildings are available in city more. The visual inspection of the buildings shows that in the elevation of building seems to be regular. Out of considered 63

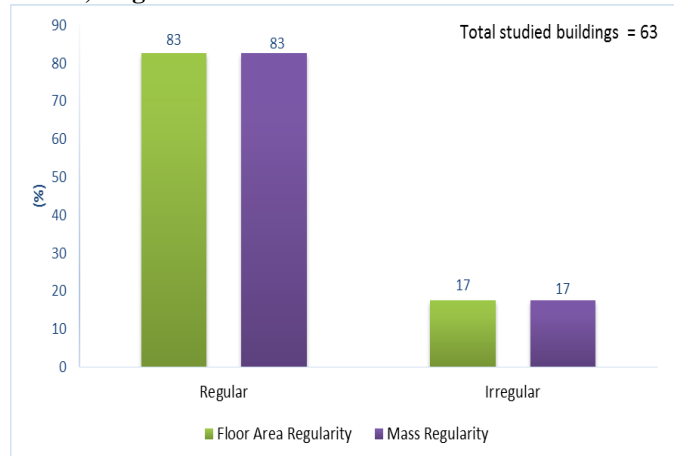
Fig 0.b : Regularity of building in elevation

buildings 83% buildings have almost regular floor area and mass. This means most of the buildings are almost same floor area in different stories. In this case it is considered that staircase cover floor is not considered in the regularity of floor area and mass.

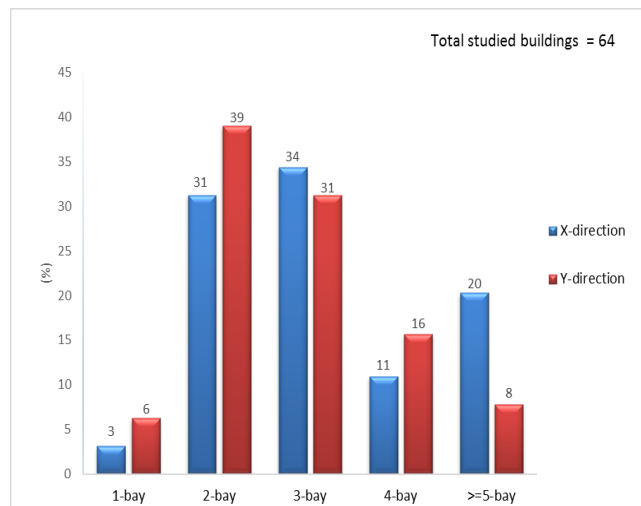
Fig 0.b: Numbers of bays in both direction

Fig 0.b shows number of bays in both major direction in the surveyed buildings. In the survey it is considered that along the road is x-direction and perpendicular to road is considered as y-direction. In the one bay building in x di-

rections are used for shopping and residence purpose where land is expensive. The results show that two and three bay buildings are predominant in both directions. These types of bays are used mainly in common buildings. In case of the bay numbers more than four, bays along x – direction(along the road) is more than y – direction in the comparatively cheap land keeping more space in back side and wider along the road for the purpose of shopping .

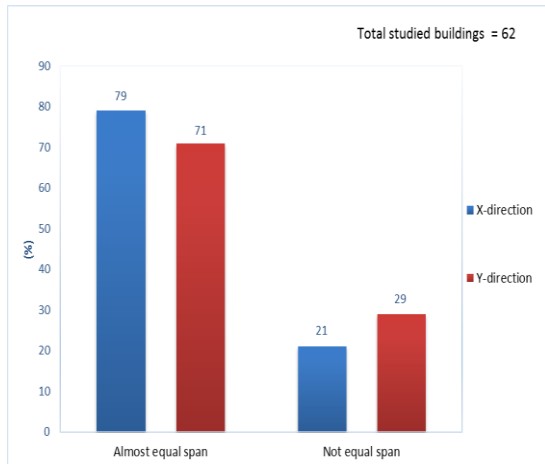
Fig 0.c: Equal span of bays in both direction

Fig 0.c shows large portion of surveyed building of 79% and 71% have almost equal span in x - and y - directions respectively. Spans are considered equal if differences of spans are not more than 1.5 m. It shows that drastically differences in span is not in the most of the building which

is the positive part from the point of view of structural aspect.

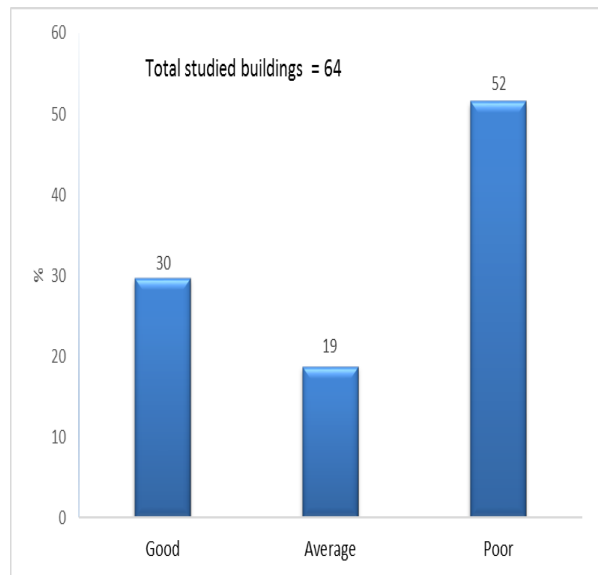
Fig 10.b : Quality of concrete in vibration

Quality of material also influence the strength of the structural members and consequently to structural system itself. Fig 10.a shows that out of studied 64 numbers of buildings, 61% of buildings have poor quality of concrete. Similarly, Fig 10.b shows that the quality of concrete in vibration shows 52% buildings have poor quality. This is the

cause for the crushing of concrete in the column support and joint. The results show that TMT steel were used mostly in the buildings which are more vulnerable in compared to Tor steel used buildings (see Fig 10.c). This might be because TMT have less ductility than Tor steel.
